Meadow Cottage, Brook, Albury GU5 9DJ
Domestic Buildings Research Group Report 2170
Albury History Society - alburyhistory.org.uk

REPORT No 2170

ALBURY BROOK MEADOW COTTAGE TQ 060 462

REPORT No. 2170 A

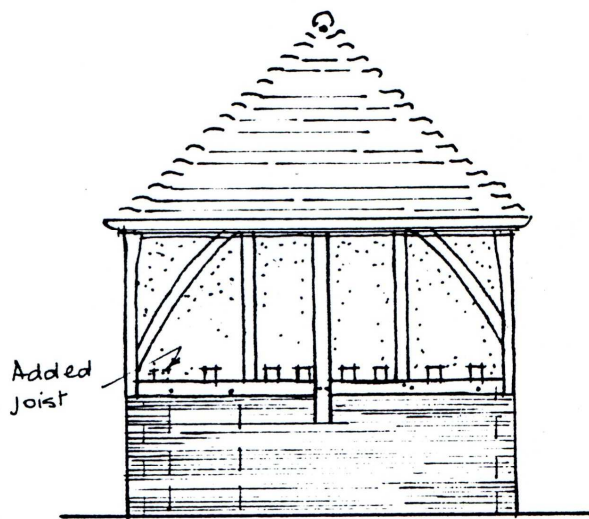
E. END A-A

Timber frame, wattle & daub.
Brick replacement to ground
floor.

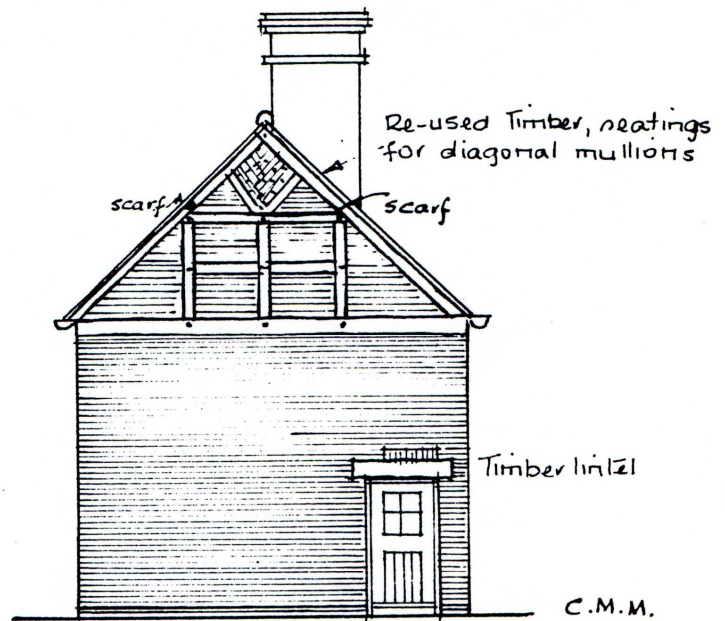
W. END D-D

Brick facing over timber
framing. Brick infill, herring bone
at apex.

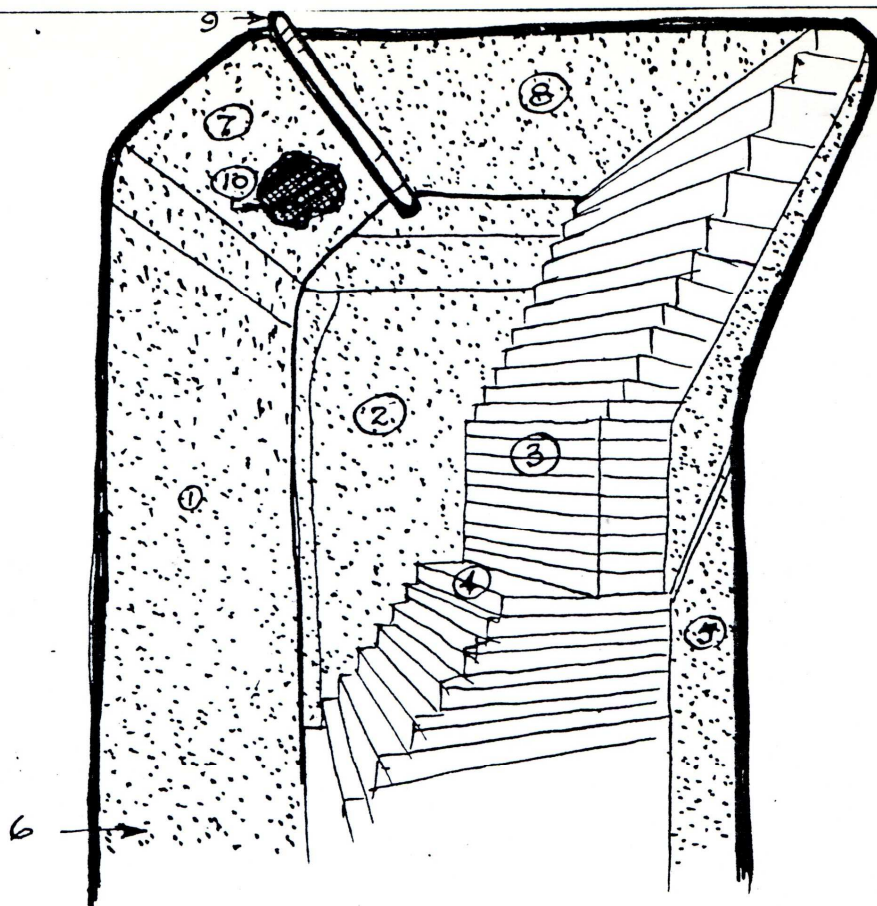
VIEW THROUGH HOLE IN
BATHROOM WALL

VOID BETWEEN CHIMNEY ON FIRE
FLOOR & S. [OUTSIDE] WALL

1. 10" wattle & daub sooted
2. Wattle & daub sooted
3. New brickwork built from inside chimney
4. Old brickwork
5. Brickwork sooted
6. Bathroom wall - 1" daub, 1/4" lathes nailed from inside, 1/2" daub, sooted
7. Daub sooted
8. Boarding sooted
9. Fir rail
10. Hole where straw was inserted. Prox. 1 bale removed

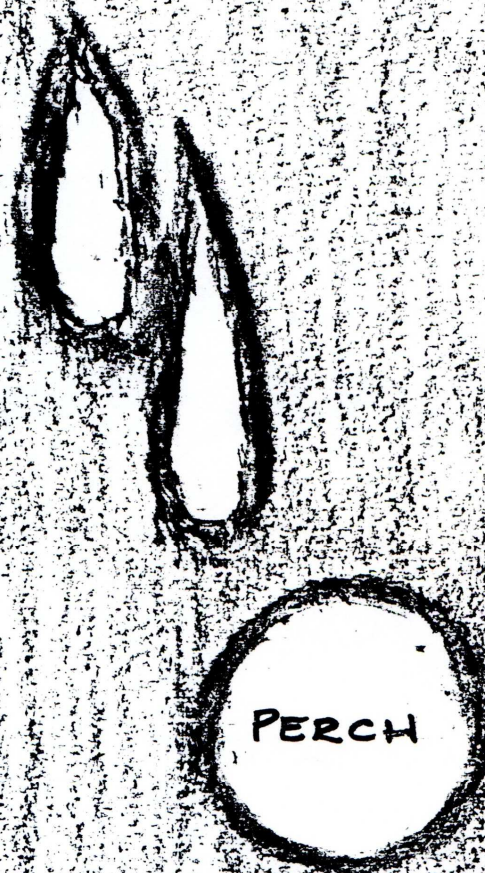
TAPER BURNS ON CENTRE POST ON A-A.
IMMEDIATELY BEHIND BEDSIDE LAMP SHADE!

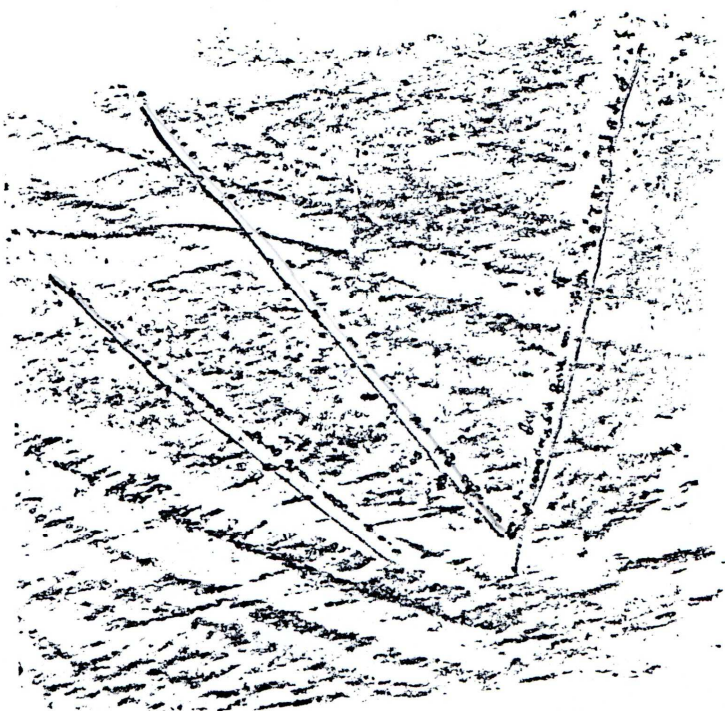
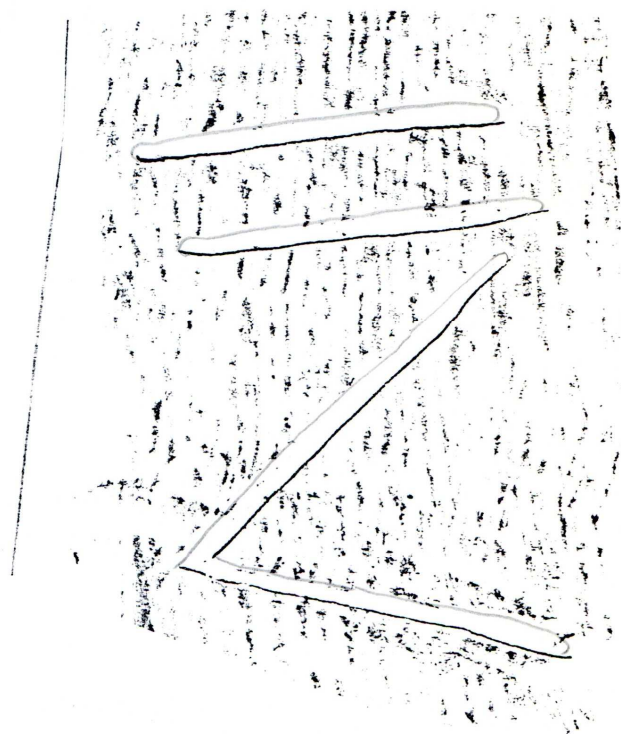
Carpenter's assembly mark on sorted rafter - on white rafter

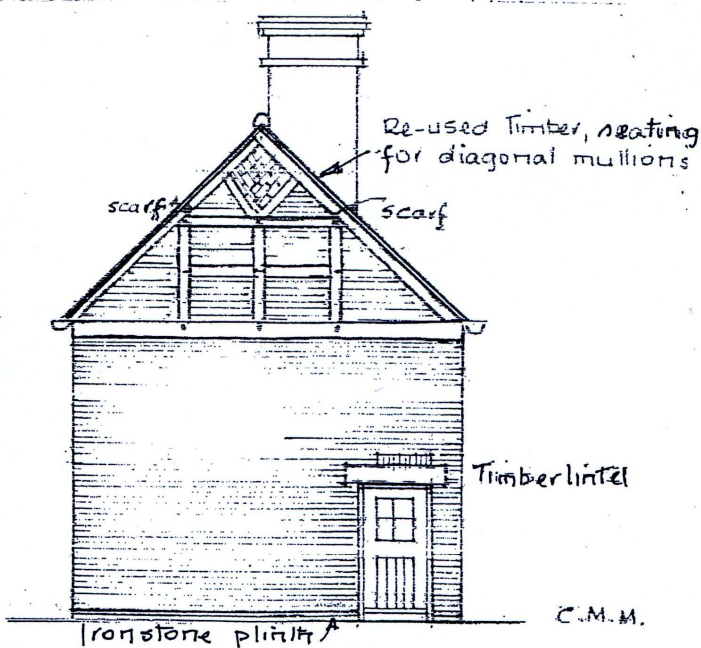
W. END D.D.

Brick facing over stone to ground floor
3" brick over. Brick infill, herring bone
at apex.
